Impact Abrasion

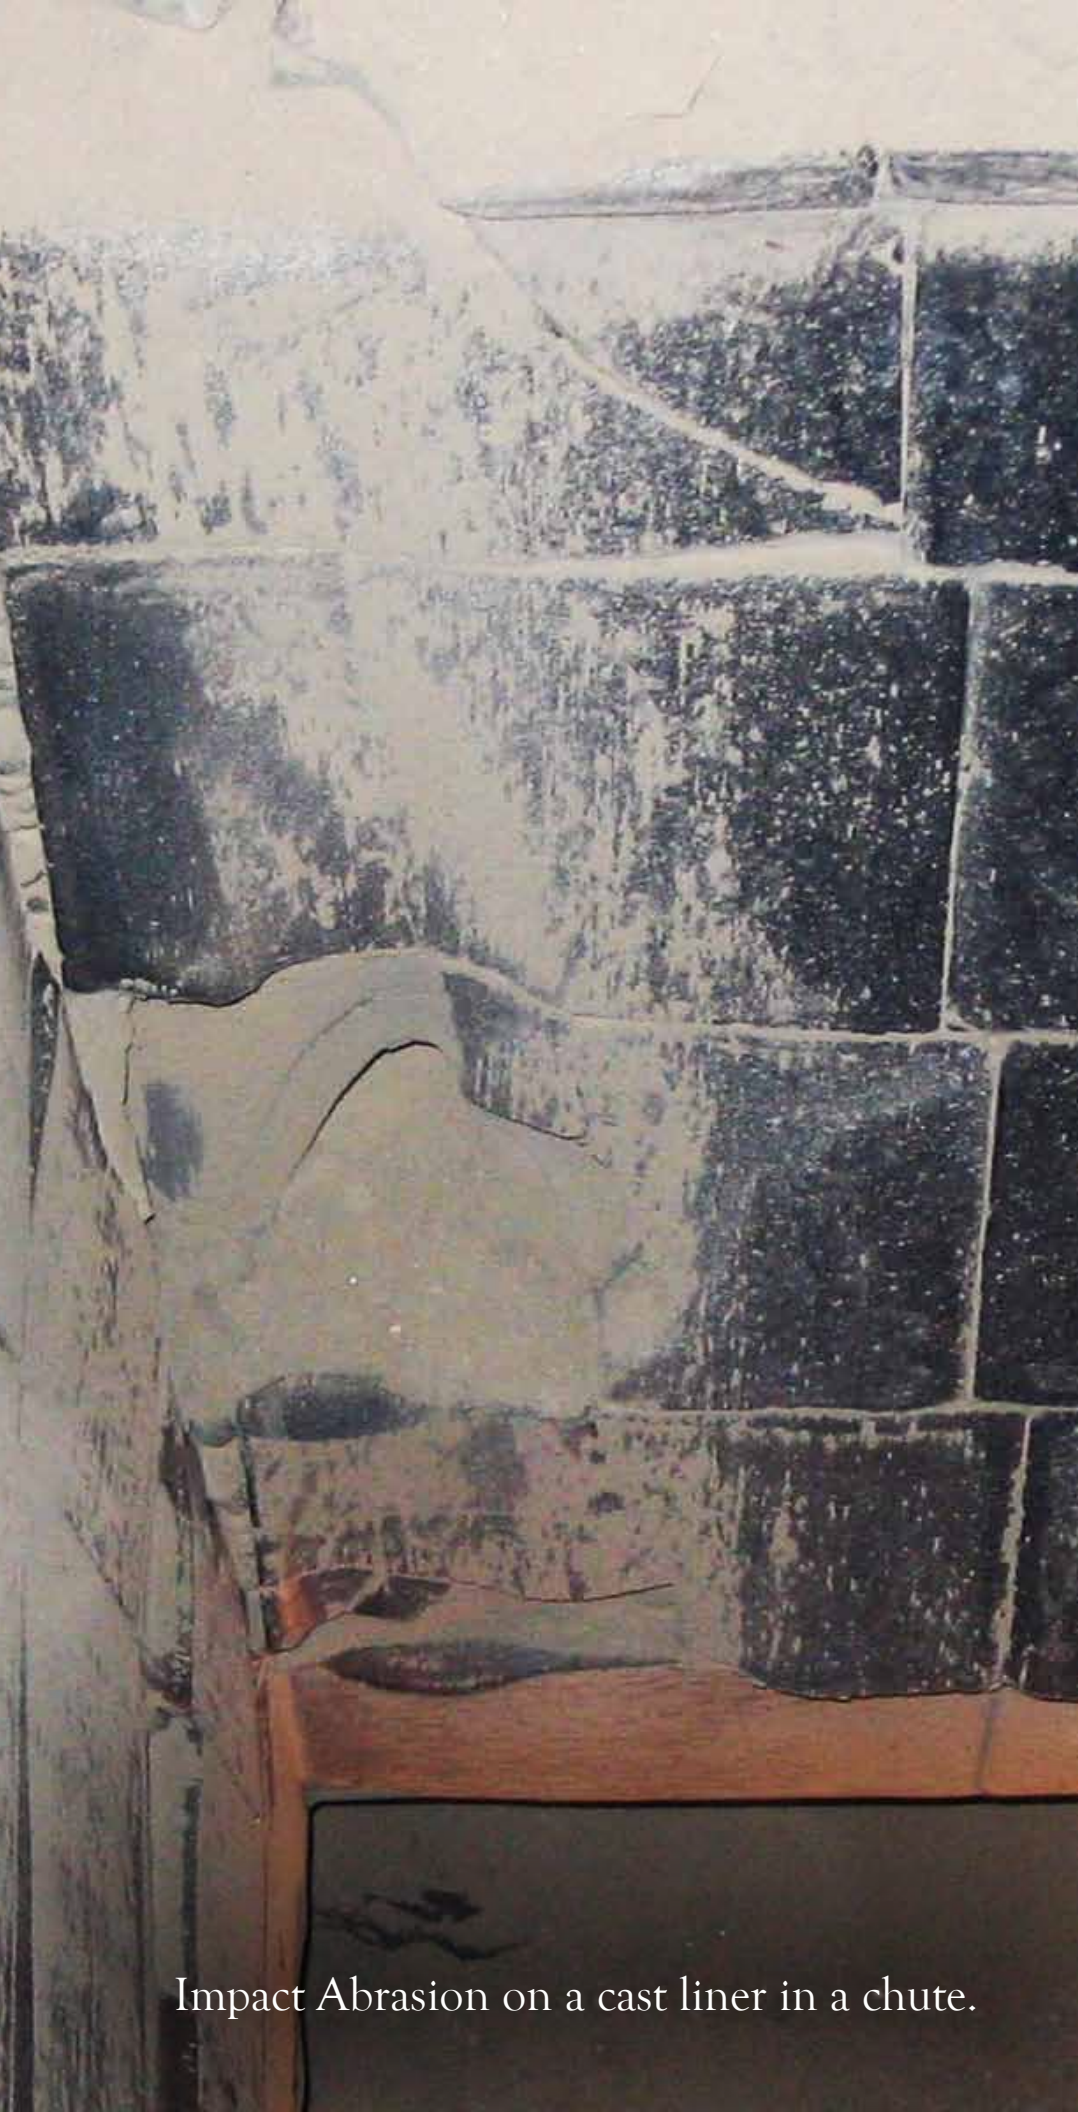
Impact Abrasion on a cast liner in a chute.

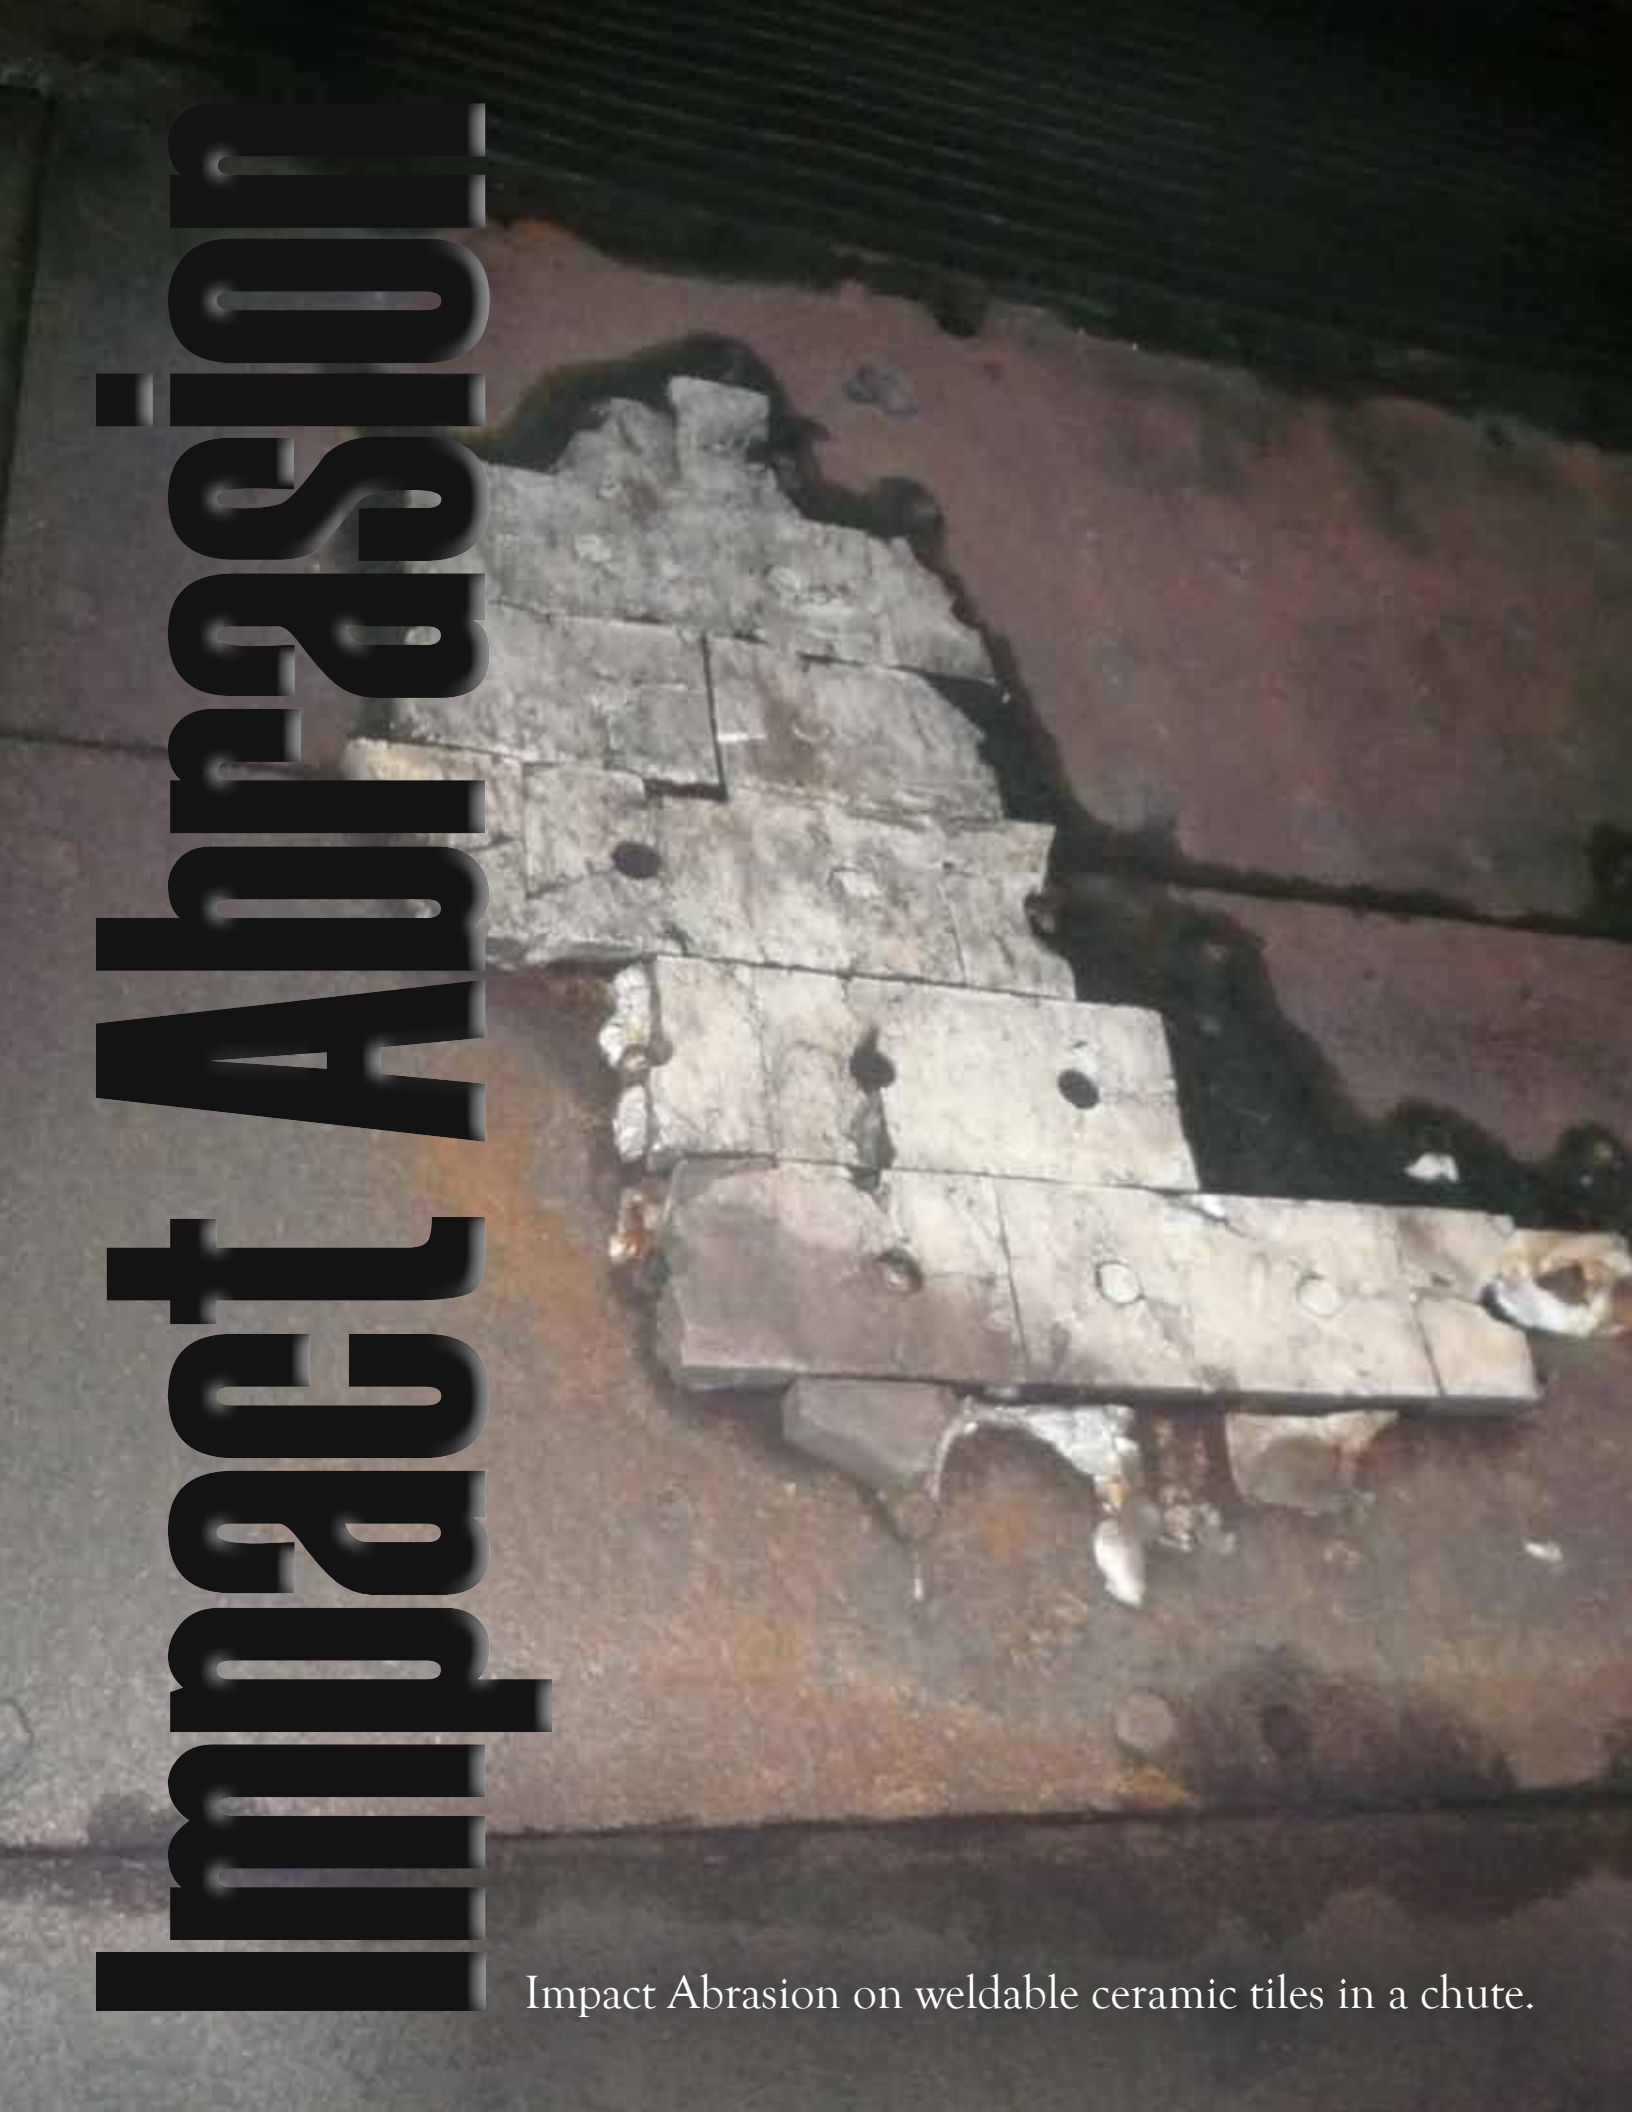
Impact Abrasion on weldable ceramic tiles in a chute.

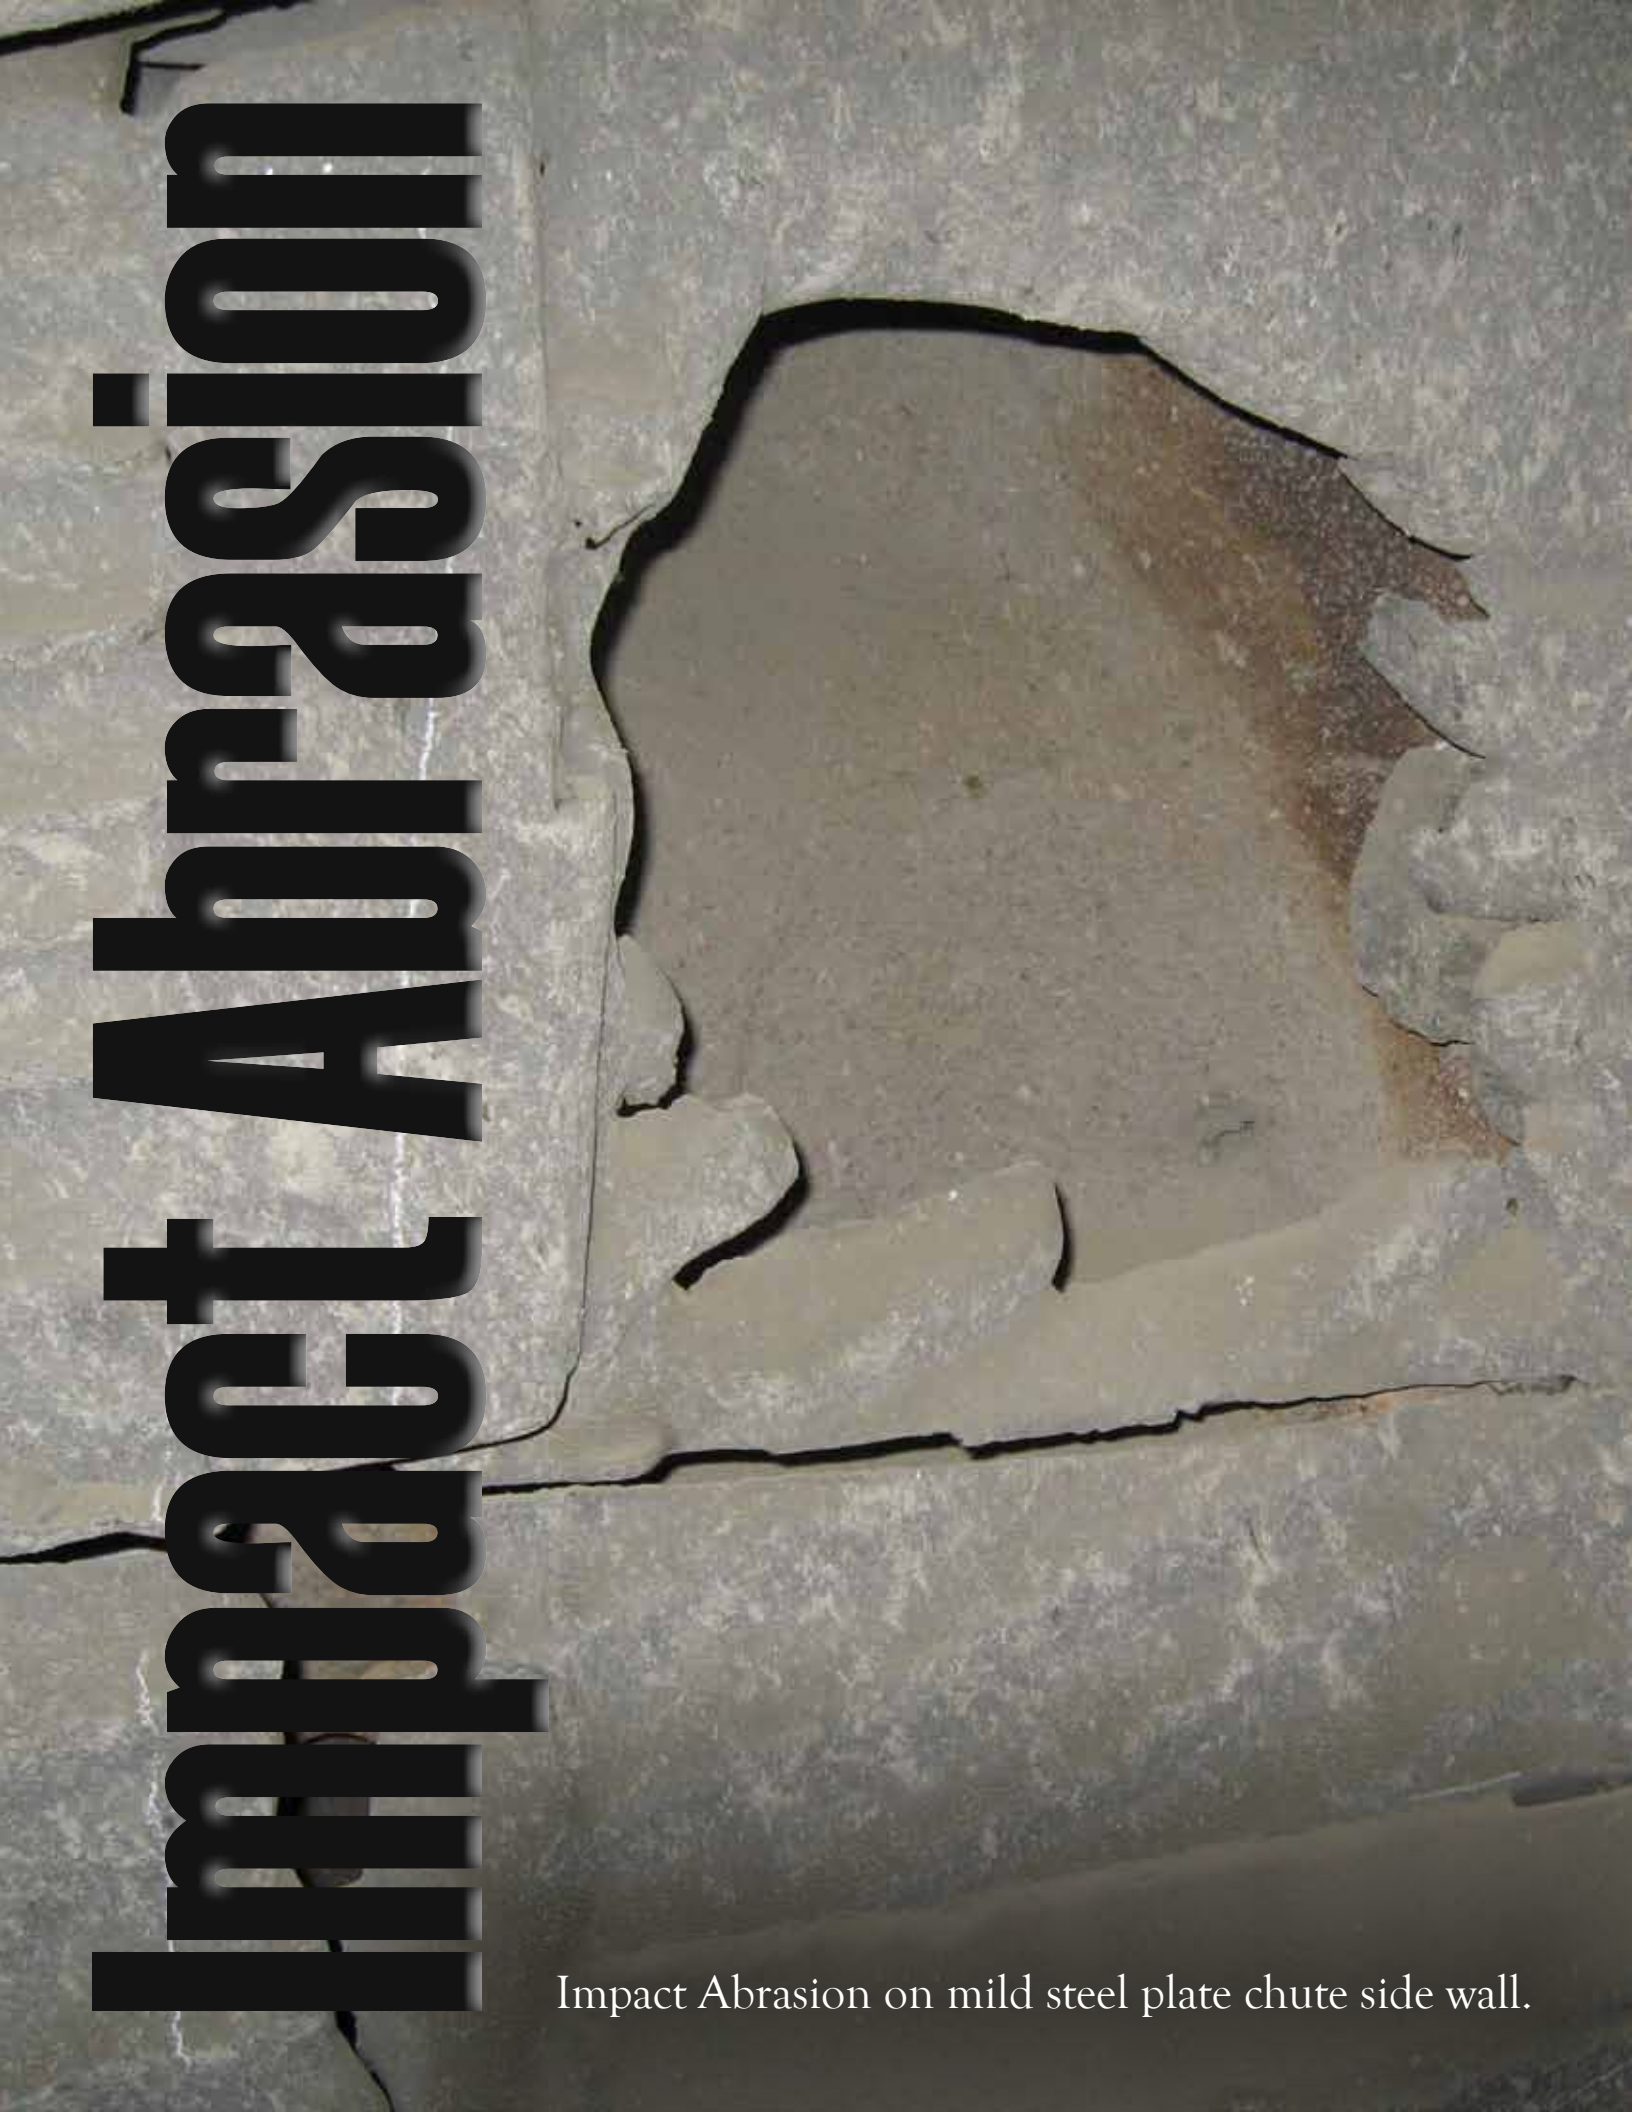
Impact Abrasion on mild steel plate chute side wall.

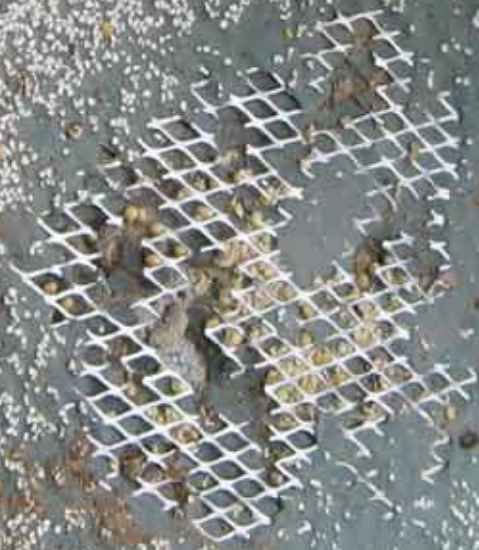
Impact Abrasion on a ceramic embedded urethane lined chute.

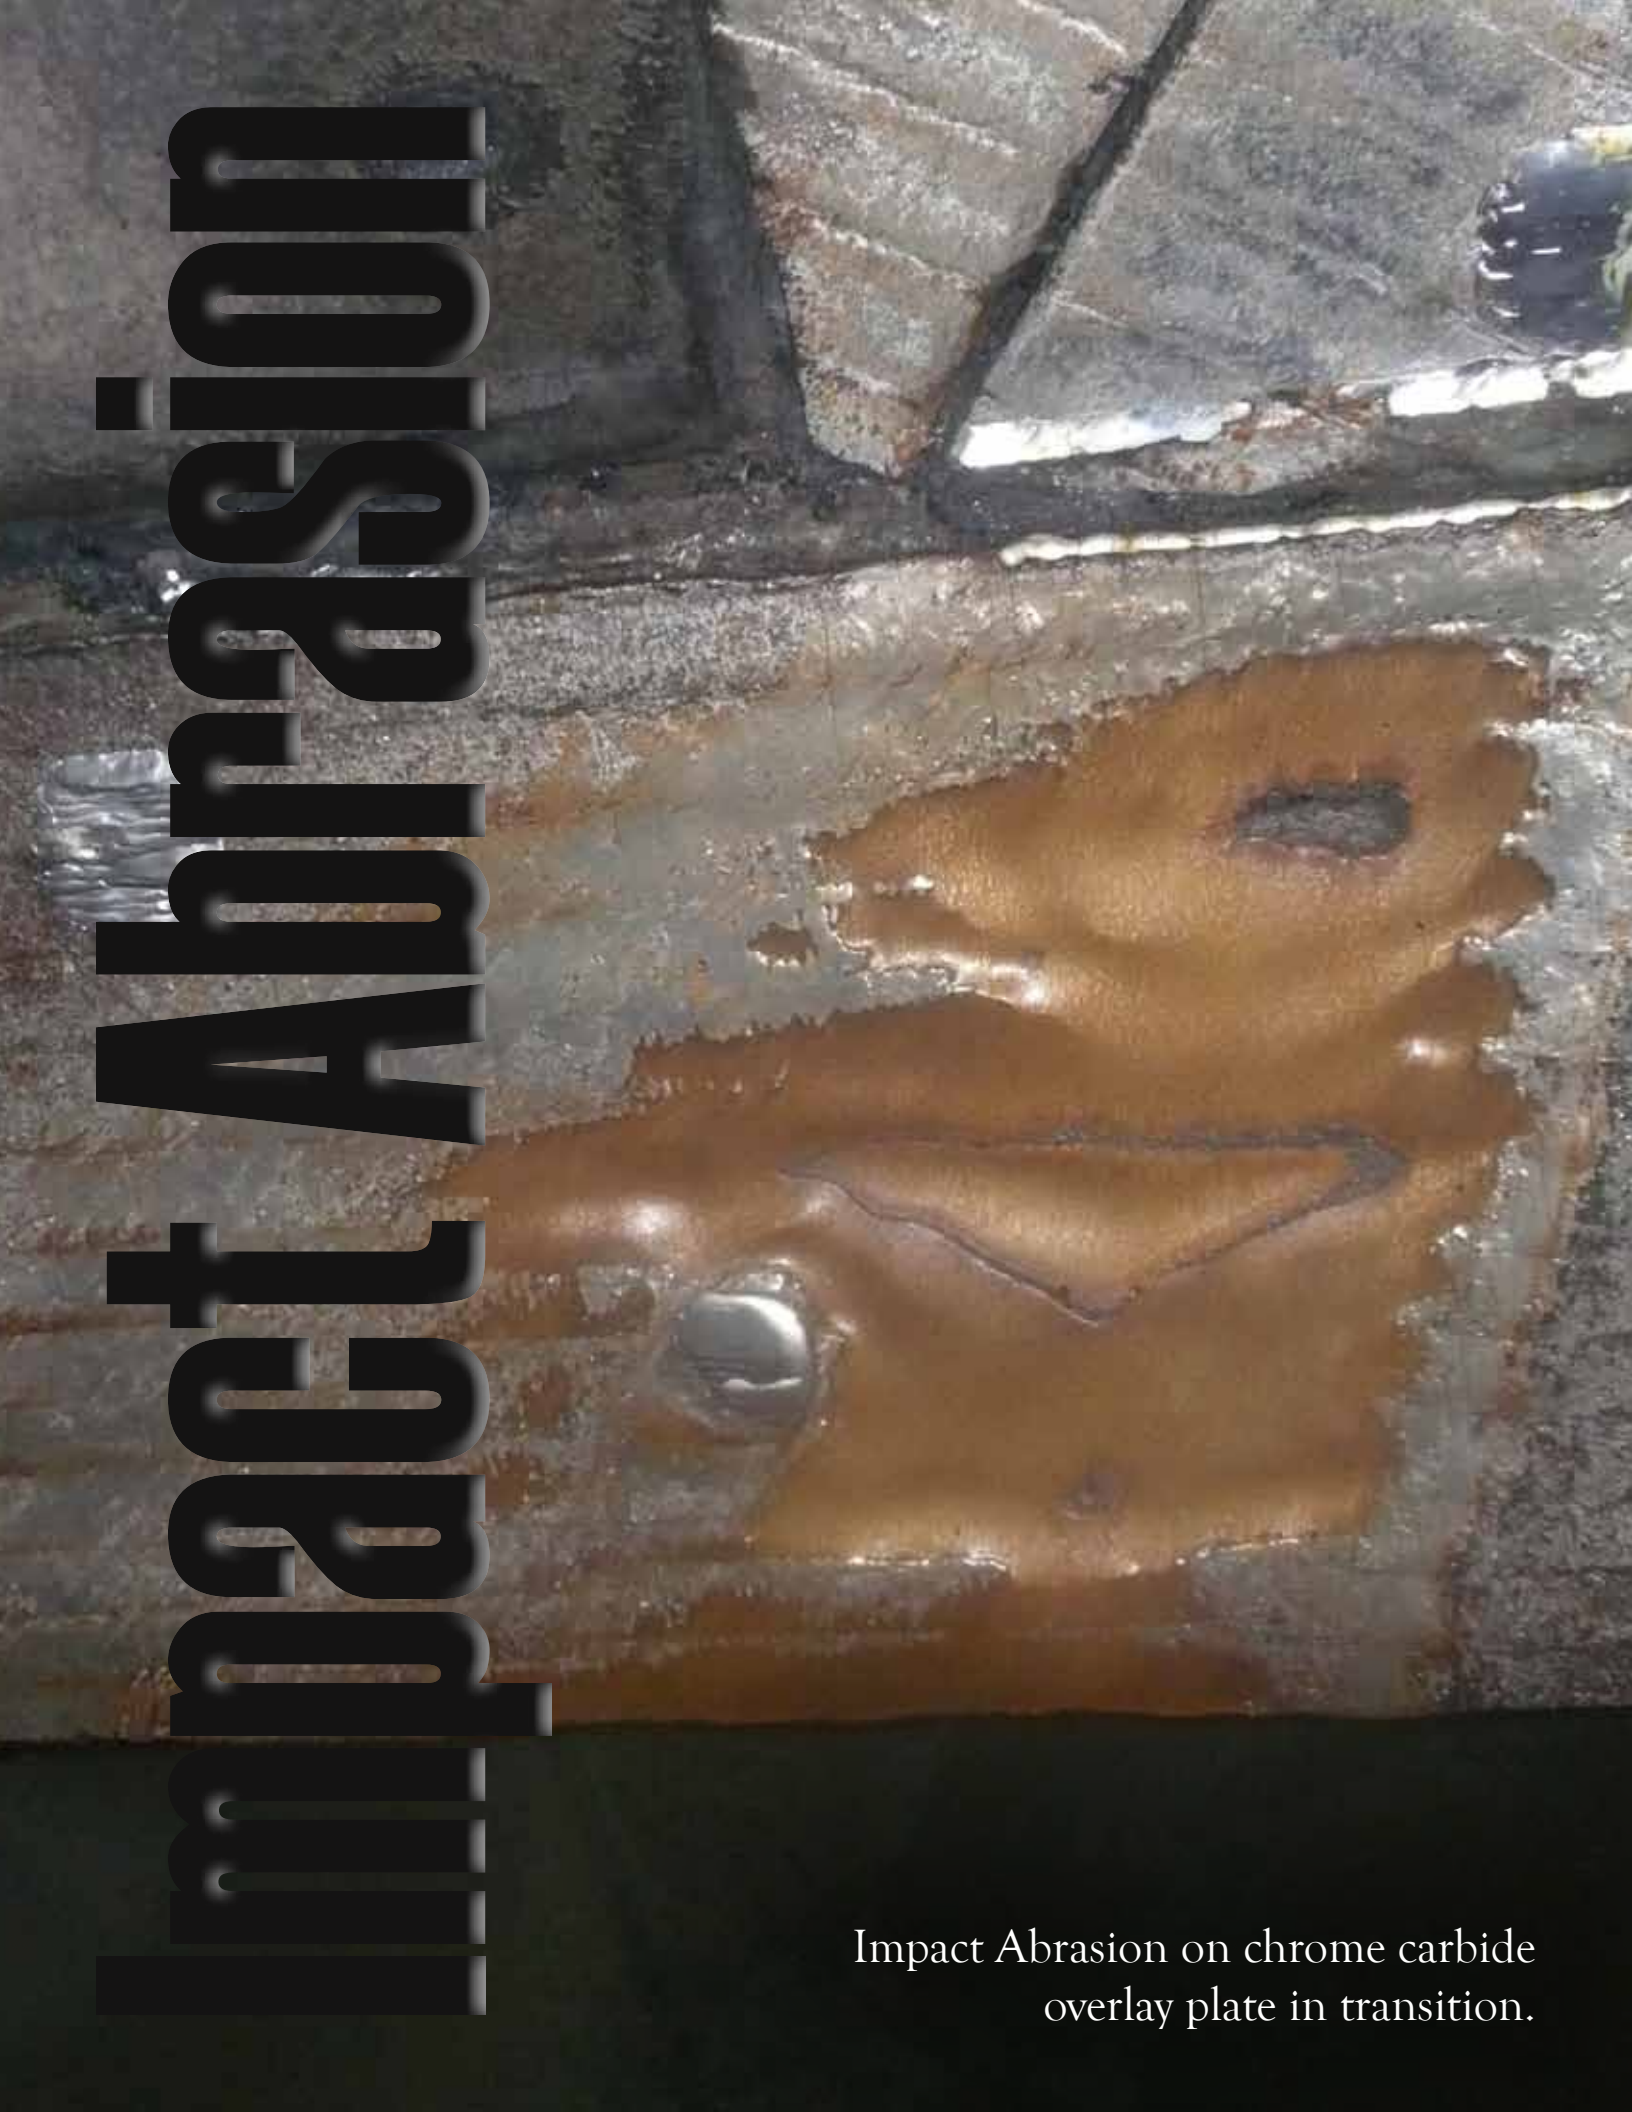
Impact Abrasion on chrome carbide overlay plate in transition.
