Conical Salvation

By James Huey, Jim Daum & Mike Sexton

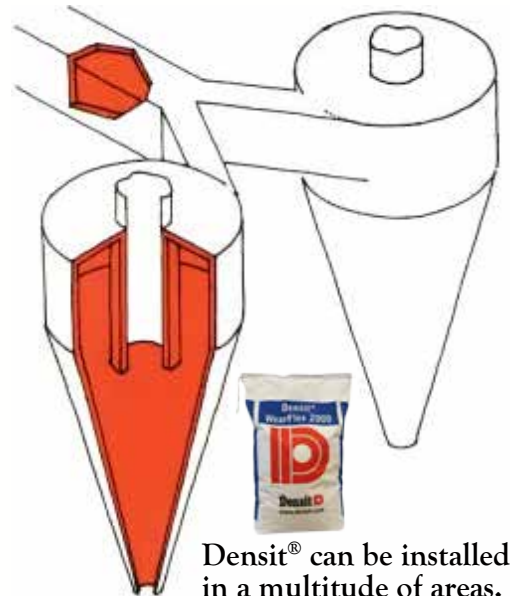
While walking through a Barite plant in southwestern United States, **Wear-Con Wear Specialist**, Jim Daum, noticed a cyclone that was in ill-repair. He inquired as to the fate of this perforated cone. The Operations Superintendent informed him that the cone was too far-gone and that it would have to be replaced with a new one. This would entail removing a section of the roof from the building; disconnecting all kinds of pipes, ducts, and wiring; and then uninstalling the cyclone. A crane would have to be rented to remove the old cyclone and drop in the new one. This would not only come at an incredible

Jim informed the Operations Superintendent that the cyclone was not only salvageable but could be rebuilt to a better-than-new condition at a fraction of the cost. How? With **Densit®**! Now he had their attention. **Wear-Con Densit® WearFlex™** is a chemically bonded, Corundum-Ceramic, wear-resistant lining. It is a trowelable, one-component, ready-mix, wear compound that is combined with wear-resistant aggregates to provide a tough and long-lasting wear solution. **WearFlex™** is applied directly to an anchoring mesh in

Three months later, the **Wear-Con Field Services Crew** was busy repairing the cyclone and lining it with **Densit® WearFlex™**. The job only took 8 days and cost about 1/3 of what the total cost of installing a new cone would have. Minimal down time, minimal expense, and best of all...no more maintenance for a long, long time. And how has it held up so far? There is absolutely no noticeable sign of wear at all. It's better than new!

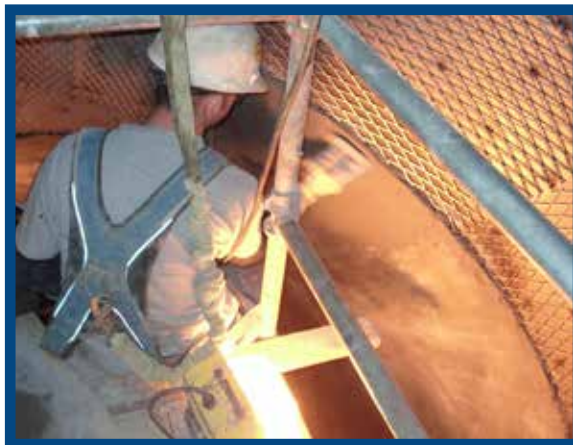
Densit® can be installed in a multitude of areas.

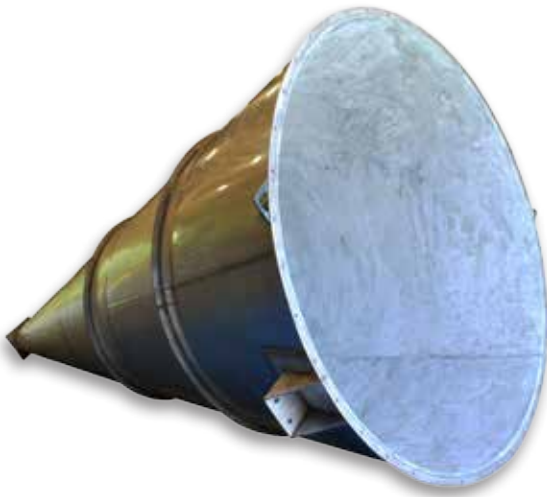
A large grain processing plant in the Midwest installed a new de-hulling cyclone many years ago. Within 6 months of service, the customer began patching it on a regular basis because of wear. Slowly but surely this cyclone was disappearing. Considerable maintenance and downtime was beginning to add up, and eventually, the cyclone would have to be replaced with a new one—only to start the whole process all over again.

Facing the prospect of continual patching and the inevitable replacement of the cyclone, this Midwest soybean processing plant decided to go with James' advice. **Wear-Con's Field Service Crew** installed **Densit® WearFlex™** chemically bonded, Corundum-Ceramic, wear-resistant lining to the interior of the cyclone. (The same **Densit® WearFlex™** that has been installed in cement plants and mining operations for years.) This came at considerable savings over the prospect of having to remove and install a new cone.
