# Molehill out of a Mountain

By Dennis Todd & Mike Sexton

(Reprinted from the article titled "Molehill out of a Mountain" as found on page 57 in the April 2011 magazine World Coal.)

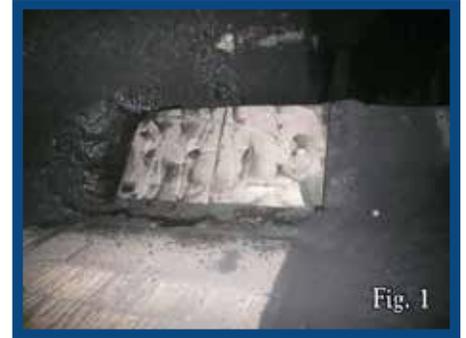
Fig. 1

without success. A new arrival to the plant in 2006 demonstrated that a viable armor of protection could be used in the war on wear with Appalachian coal. This plant began the testing of **Wear-Concepts' SHC800™ Wear Panels** in a few areas such as in coal chutes and on coal conveyor deflector plates (Figures 1 and 2). The first liner plate shows that the **SHC800™ Panel** could withstand the constant pounding of over 4 million tons of coal coming through this chute. The coal chute deflector plate not only held up to the abrasive wear of the Appalachian coal, it also withstood the constant 20 ft. drop of the coal. The **SHC800™ Wear Panels** were designed to have the wear characteristics of a CCO liner, but the challenge was how to handle the impact. The **SHC800™ Panel's** chemistry has a propitiatory blend of special alloys. In addition, a unique heat treatment process, brings the hardness of the panels to a 55 - 58 HRC which provides

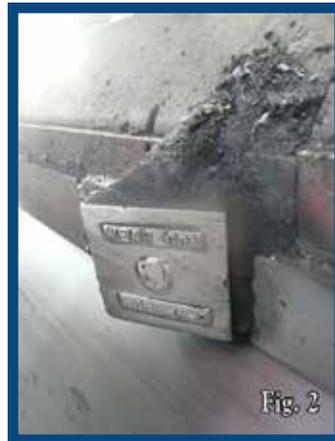
Fig. 2

still very visible (Figure 2). Based on this success, it was decided to use the product for the inner skirtboards in the load out areas of the coal conveyors (Figure 4). The **SHC800™** Wear Panel not only provided a wear resistant surface as a side liner, but also minimized the wear and tearing of the conveyor belts because of the slow constant rate of abrasion and impact resistance. In some areas of the plant where AR500 or CCO was used previously as inner skirtboards, the problem was the irregular wear or the sharp edges that developed on the liners. The pocket openings with the AR500 inner skirtboards, (due to wear) allowed the coal to congregate and eventually created wear on the belt. The CCO, which has a mild steel substrate, wore to a sharp edge and then caused tearing of the belt when adjustments were trying to be made to the inner skirts. But the **SHC800™** Inner SkirtBoard

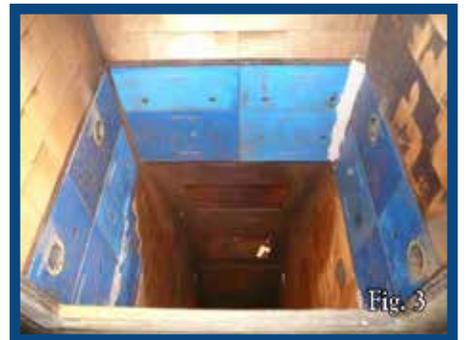
Fig. 3

the toughness needed to hold up to the impact without the fear of breakage from this type of impact. Because of their good qualities, the plant started to use the wear panels in other impact areas (Figure 3).

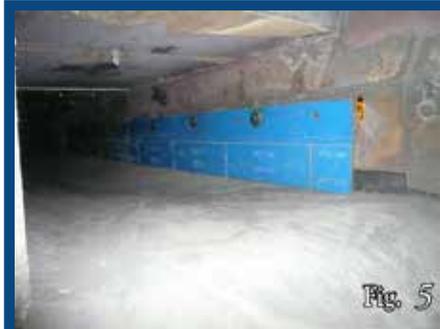
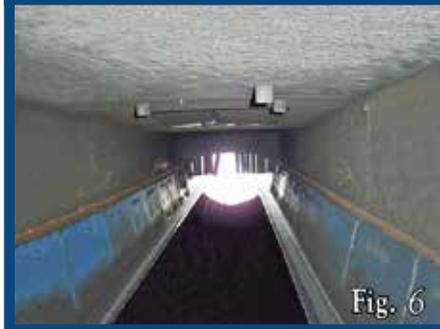
Over time, other plants heard of the success with the use of the **SHC800™** Inner SkirtBoard Panels and also began to use the product (Figures 5 and 6). Now new coal handling systems are being designed and installed with the use of the **SHC800™** Inner SkirtBoard Panels (Figure 7). Appalachian mountain coal was finally tamed.
